Manhole Inspection Summary

Manhole # S33II_006MH

Insp Date: **4/2/07 9:30 AM**

Location Address: **1700 LANVALE ST**

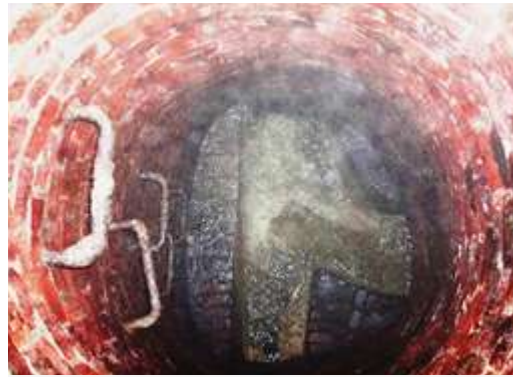
Top View

Count: **6** Missing: **0** ☒ **Corroded**

☒ **Evidence Of Surcharge** Depth: **1.5** (ft.) ☐ Active Surcharge Present

Corroded steps. Evidence of surcharge - Bench debris.

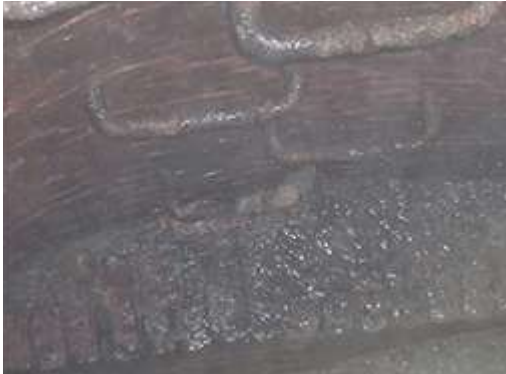
Evidence of surcharge

Lowest step.

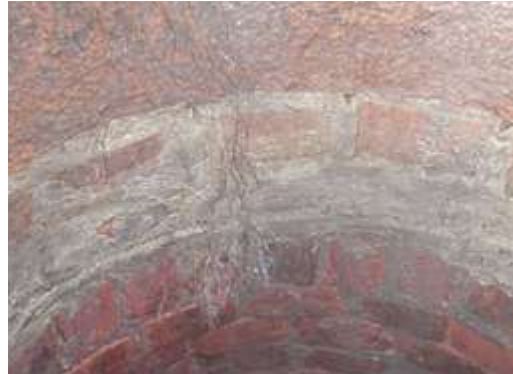
Defect

Condition: ☐ Sound ☐ Cracked ☒ **Root Intrusion** ☐ Loose Brick ☐ Deteriorated

Infiltration: ☐ None ☒ **Joint** ☐ Cracks ☐ Mortar ☒ **Roots** ☐ Wall

Adjustment root intrusion and infiltration.

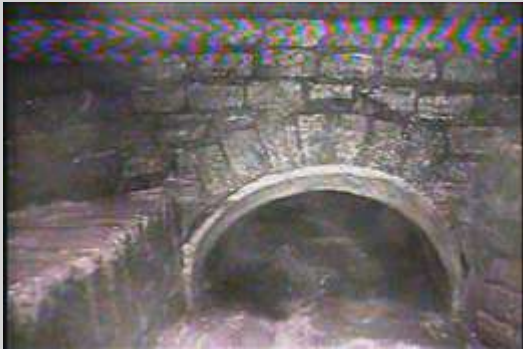
18 in. Circular Gravity Sewer Pipe Out @ 12 O'Clock

Condition: ☐ Sound ☐ Cracked ☐ Root Intrusion ☐ Loose Brick ☒ **Deteriorated**

Infiltration: ☐ None ☐ Joint ☐ Cracks ☒ **Mortar** ☐ Roots ☐ Wall

Barrel deterioration and infiltration.

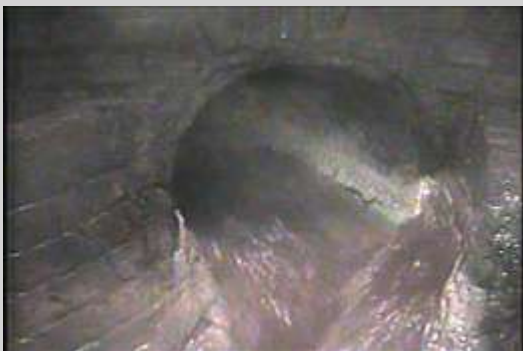
18 in. Circular Gravity Sewer Pipe In @ 3 O'Clock

Infiltration: **Evidence** Pipe Seal Cond: **Broken**

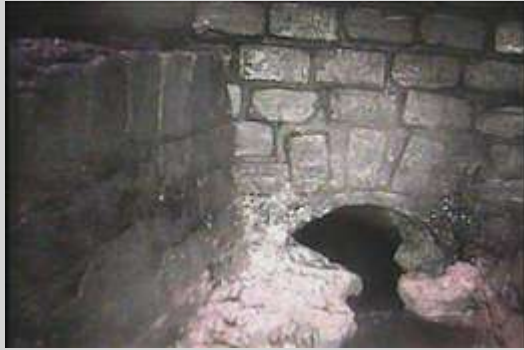
Pipe In @ 6 O'Clock

Channel debris/grease.

Deposits: ☐ None ☐ Mud ☐ Sludge ☐ Debris ☒ **Grease**

Deposits Extent: **Medium**
